**Flood Control Project Maintenance  
Levee Inspections**

**Fall 2018 Levee Maintenance Deficiency Summary Report**

**Sacramento River Basin**

**Reclamation District No. 1500 Sutter Basin**

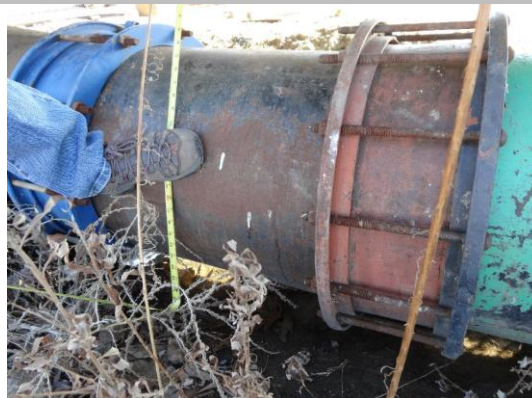
Photo 2 of 3 : UCIP\_FA\_2018\_28603\_52666.jpg

WS view: leaky pipe near pump platform. Pipe leaks from the joint.

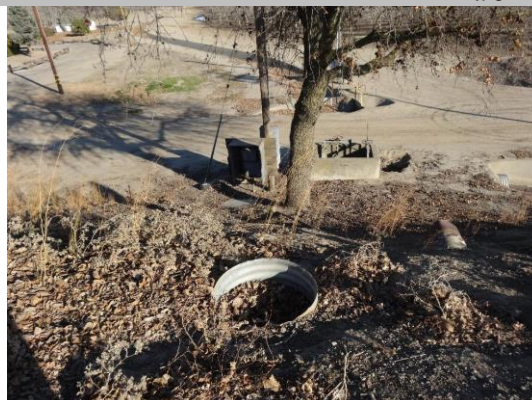
Photo 3 of 3 : UCIP\_FA\_2018\_28603\_52665.jpg

LS view: siphon breaker in CMP riser on levee slope (bottom) and concrete distribution box (top) on levee toe.

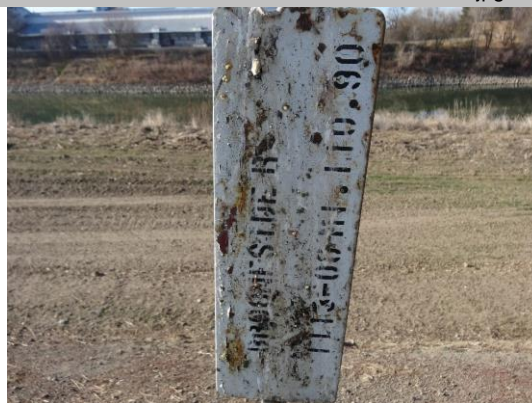
Photo 1 of 2 : UCIP\_FA\_2018\_41728\_52673.jpg

Comment Code						
Inspector Comment						
FS_ID:41728 DS_ID:20074 EP_NO: 8765 Repair Type: Non-Urgent Crossing Status: Found UCIP Comments: Burried Concrete headwall on landside toe. Should verify pipe has been properly abandoned.Utility tag plate on waterside shoulder.No pipe found. FIELD_STRUCT_DESC: *ABANDONED* 48-inch by 48-inch reinforced concrete box irrigation discharge culvert through the levee, 10 feet below the crown. (48-inch by 48-inch concrete culvert retained under Permit No. 9175, 1973 - David S. Lewis, DBA Broomieside Farms. To sleeve a 20-inch steel irrigation discharge pipe through the existing concrete culvert from a new slant-type pumping facility authorized under Permit No. 8765, 1973 - David S. Lewis, DBA Broomieside Farms. The 20-inch discharge pipe will be enclosed in a 30-inch, 0.375-inch wall steel pipe.). [Additional Reference(s): DWR Levee Log, 2005. USACE Sacramento O&M Manual 128, March 1960, (HLM 25.80)]. FS Date: 1/15/2014

WS view: utility tag plate on waterside shoulder. No pipe found.

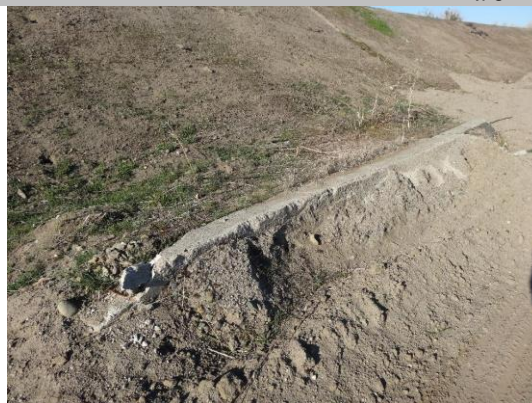
Photo 2 of 2 : UCIP\_FA\_2018\_41728\_52672.jpg

LS view: concrete headwall on landside toe. No pipe found.

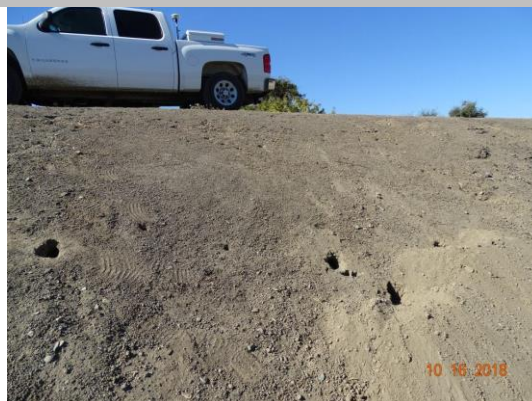
Photo 1 of 1 : FA\_2018\_RD1500\_189\_95\_20181018\_00230.jpg

LM Start	25.50	Rating **	M	Issue No.	95
LM End	25.50	Issue Type +	Ma	Location *	LS
Category	Earthen Levee			GPS Latitude/Longitude	
				Start	End
Item	Animal Control			38.952967 °	38.952967 °
				-121.837730 °	-121.837730 °
DWR ID	DWR_RD1500_01_f_2018_95				
Comment Code					
A3 : No rodents visible, but rodent burrows visible; need to backfill and compact or grout burrows.					
Inspector Comment					
Rodent holes on the landside slope.

View of rodent holes on the landside slope. Fall 2018.

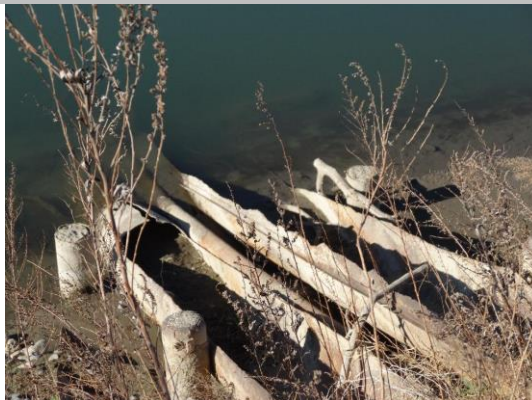
Photo 1 of 2 : UCIP\_FA\_2018\_28629\_52709.jpg

Comment Code						
Inspector Comment						
FS_ID:28629 DS_ID:20014 EP_NO: 10057 Repair Type: Non-Urgent Crossing Status: Found UCIP Comments: May need proper abandonment. FIELD_STRUCT_DESC: *ABANDONED* 1 of 2: 24-inch steel irrigation discharge pipe through the levee, 7.1 feet below the crown. Two corrugated metal cutoff walls. Siphon breakers in 24-inch and 30-inch corrugated metal pipe (CMP) risers on the landside (LS) shoulder. 2-inch conduit through the levee. Installed by USACE in 1958. Wooden walkway to two slant pumps on a steel pile structure on berm. Meter pole and switch panel at the LS toe. (Steel discharge pipes, slant pumps, and all other appurtenances retained under Automatic Board Order (ABO) issued as Permit No. 10057, 1974 - David S. Lewis, care of Broomieside Farms, [RM 112.06]. Moved to HLM 26.50 under Permit No. 16165, 1994 - Pelger Mutual Water Company/Murray, Burns, and Kienlen). [Additional Reference(s): DWR Levee Log, 1993. USACE Sacramento O&M Manual 128, March 1960, (HLM 26.84)]. FS Date: 1/15/2014

WS view: abandoned 24" and 30" steel pipe on river bank.

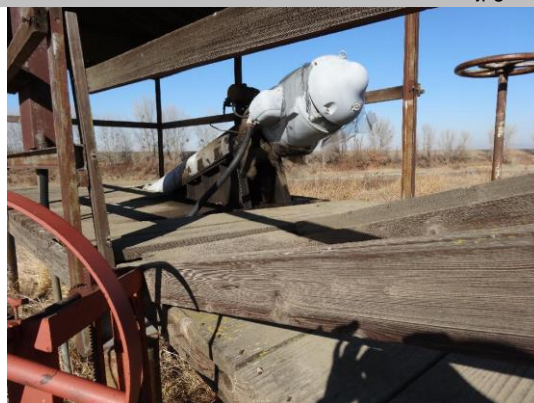
Photo 1 of 3 : UCIP\_FA\_2018\_28631\_52720.jpg

FS\_ID:28631  
DS\_ID:20015  
EP\_NO: 10052  
Repair Type: Non-Urgent  
Crossing Status: Found  
UCIP Comments: Obstructed siphon breaker. Leaky pump.  
FIELD\_STRUCT\_DESC: 18-inch steel irrigation discharge pipe through the levee, 7.1 feet below the crown. Corrugated metal cutoff wall. 2-inch conduit through the levee, 5.5 feet below the crown. Wooden walkway to slant pump and gate valve on wooden pump platform mounted on a steel pile structure on the berm. Siphon breaker in a 24-inch corrugated metal pipe (CMP) riser on the landside (LS) slope. Meter pole at the LS toe. (18-inch steel irrigation discharge pipe through the levee, slant pump, and all other appurtenances retained under Automatic Board Order (ABO) issued as Permit No. 10052, 1974 - Clifton Lamb, [RM 112.29]). [Additional Reference(s): DWR Levee Log, 1993. USACE Sacramento O&M Manual 128, March 1960, (HLM 27.07)].  
FS Date: 1/15/2014

WS view: slant pump and gate valves on wooden platform at levee berm. Wooden walkway to the pump.

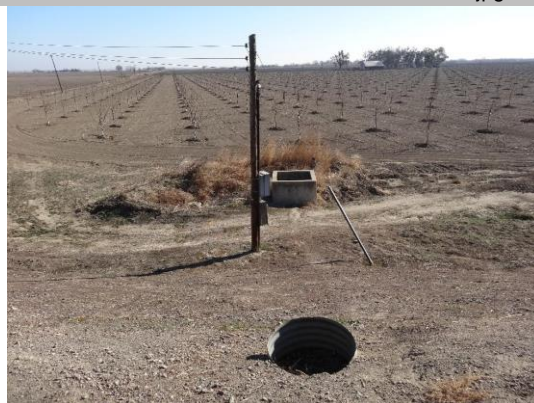
Photo 2 of 3 : UCIP\_FA\_2018\_28631\_52719.jpg

LS view: siphon breaker in CMP riser on levee slope (bottom) and concrete distribution box on levee toe.

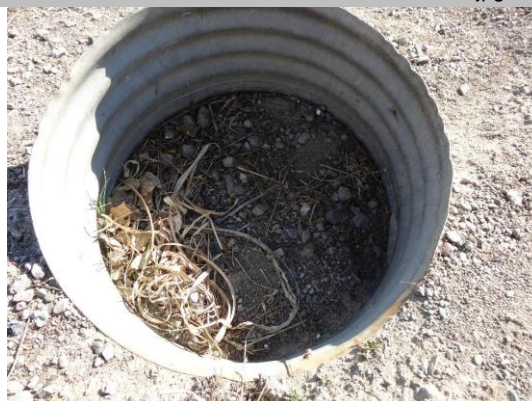
Photo 3 of 3 : UCIP\_FA\_2018\_28631\_52721.jpg

LS view: obstructed siphon breaker in CMP riser on levee slope.

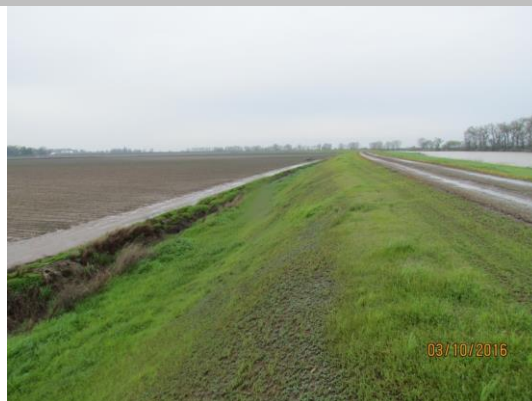
Photo 1 of 1 : FA\_2018\_RD1500\_189\_983\_20180904\_00082.jpg

LM Start	27.31	Rating **	M	Issue No.	983
LM End	27.44	Issue Type +	En	Location *	LS
Category	Earthen Levee			GPS Latitude/Longitude	
				Start	End
Item	Encroachments			38.972552 °	38.972924 °
				-121.825574 °	-121.823198 °
DWR ID	DWR_RD1500_01_s_2015_983				
Comment Code					
DT : Ditch					
Inspector Comment

View of the ditch on the landward side of the levee looking downstream. Spring 2016.

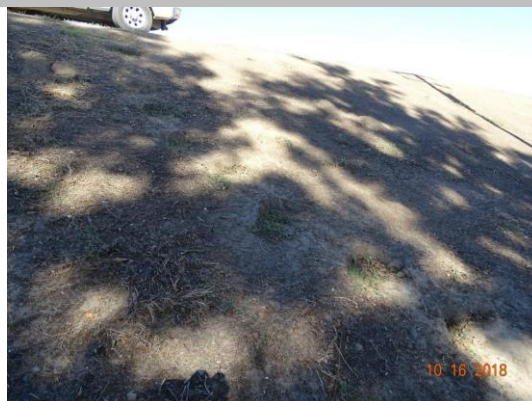
Photo 1 of 1 : FA\_2018\_RD1500\_189\_94\_20181018\_00229.jpg

LM Start	27.61	Rating **	M	Issue No.	94
LM End	27.61	Issue Type +	En	Location *	LS
Category	Earthen Levee			GPS Latitude/Longitude	
				Start	End
Item	Encroachments			38.974258 °	38.974258 °
				-121.820587 °	-121.820587 °
DWR ID	DWR_RD1500_01_f_2018_94				
Comment Code					
ST : Stairway					
Inspector Comment					
Stairs dug into the landside slope.

View of stairs on the landside slope. Fall 2018.

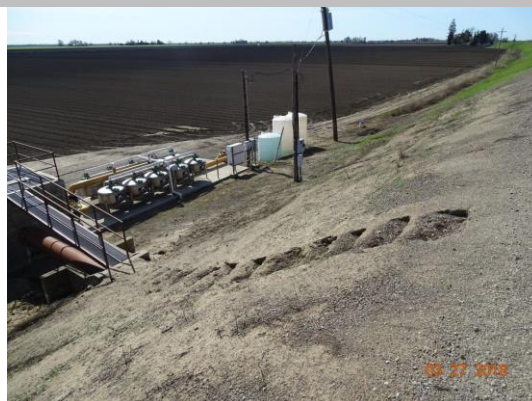
Photo 1 of 1 : FA\_2018\_RD1500\_189\_96\_20180904\_00037.jpg

LM Start	28.16	Rating **	M	Issue No.	96
LM End	28.16	Issue Type +	En	Location *	LS
Category	Earthen Levee			GPS Latitude/Longitude	
				Start	End
Item	Encroachments			38.982180 °	38.982180 °
				-121.819979 °	-121.819979 °
DWR ID	DWR_RD1500_01_s_2018_96				
Comment Code					
ST : Stairway					
Inspector Comment					
Steps dug out on the landside levee slope.

View of steps on the landside slope. Spring 2018.

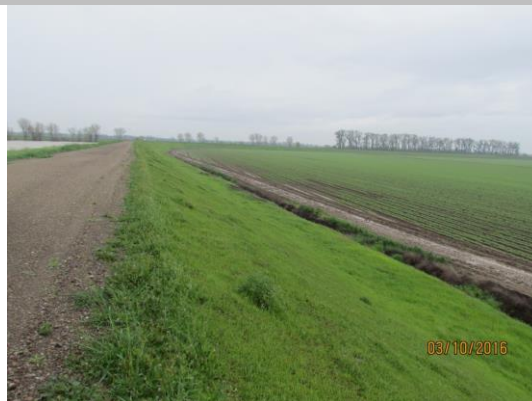
Photo 1 of 1 : FA\_2018\_RD1500\_189\_38\_20180904\_00021.jpg

LM Start	28.23	Rating **	M	Issue No.	38
LM End	29.23	Issue Type +	En	Location *	LS
Category	Earthen Levee			GPS Latitude/Longitude	
				Start	End
Item	Encroachments			38.983119 °	38.988538 °
				-121.819923 °	-121.806445 °
DWR ID	DWR_RD1500_01_s_2012_38				
Comment Code					
DT : Ditch					
Inspector Comment

View of the ditch on the landward side of the levee looking upstream. Spring 2016.

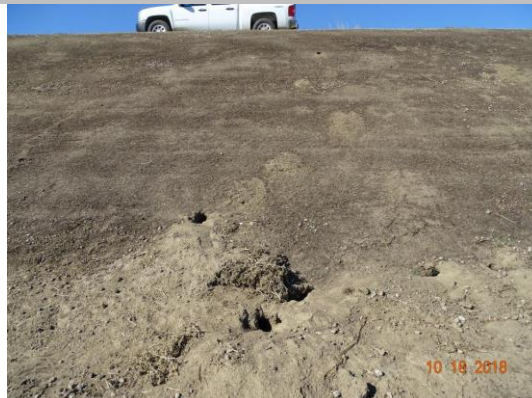
Photo 1 of 1 : FA\_2018\_RD1500\_189\_92\_20181018\_00228.jpg

LM Start	28.23	Rating **	M	Issue No.	92
LM End	28.23	Issue Type +	Ma	Location *	LS
Category	Earthen Levee			GPS Latitude/Longitude	
				Start	End
Item	Animal Control			38.983221°	38.983221°
				-121.819895°	-121.819895°
DWR ID	DWR_RD1500_01_f_2018_92				
Comment Code					
A3 : No rodents visible, but rodent burrows visible; need to backfill and compact or grout burrows.					
Inspector Comment					
Rodent holes at the landside toe.

View of rodent holes on the landside slope. Fall 2018.

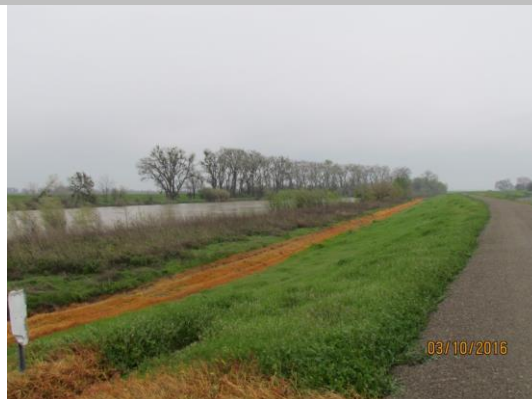
Photo 1 of 2 : FA\_2018\_RD1500\_189\_84\_20180904\_00032.jpg

LM Start	28.94	Rating **	A/W	Issue No.	84
LM End	29.17	Issue Type +	Ob	Location *	WS
Category	Earthen Levee			GPS Latitude/Longitude	
				Start	End
Item	Vegetation			38.988072°	38.988572°
				-121.811737°	-121.807520°
DWR ID	DWR_RD1500_01_s_2012_84				
Comment Code					
V8 : Environmental Requirements.					
Inspector Comment

View of the revegetation site on the waterward side of the levee looking upstream. Spring 2016.

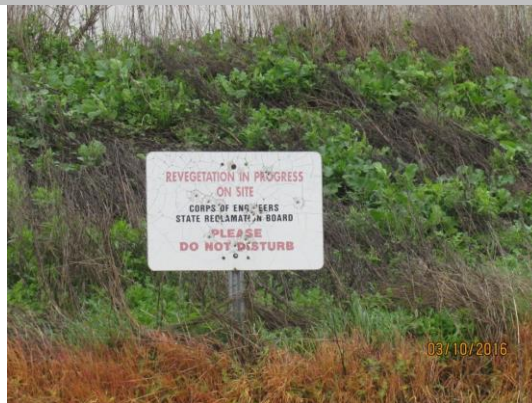
Photo 2 of 2 : FA\_2018\_RD1500\_189\_84\_20180904\_00033.jpg

Sign for the revegetation site. Spring 2016.

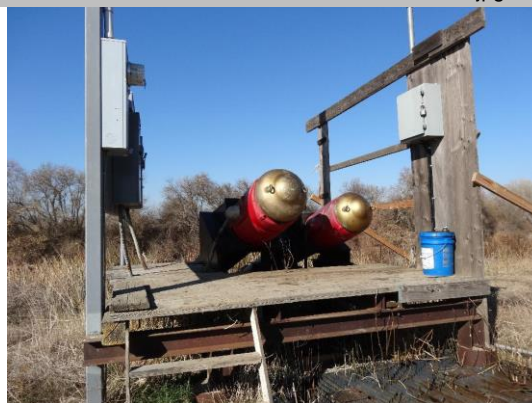
Photo 1 of 3 : UCIP\_FA\_2018\_50194\_51834.jpg

FS\_ID:50194  
DS\_ID:20113  
EP\_NO: 10054  
Repair Type: Non-Urgent  
Crossing Status: Found  
UCIP Comments: 08/29/2016: Found no evidence of leakage or subsidence. CMP risers are both silted in and need lids. Need a name change permit for new owner Brad Howalt. Possible sink hole in alignment with pipes on crown has been covered with concrete. Crossing has been downgraded from Urgent to Non-Urgent. (K. Fazel - UCIP)01/15/2014:Levee slope erosion due to leakage from siphon breaker.Water leaking from pipe near distribution box on landside levee toe.Overhead powerline. (P. Amatya - DWR)  
FIELD\_STRUCT\_DESC: 2 of 2: 16-inch steel irrigation discharge pipe through the levee, 5 feet below the crown. Corrugated metal cutoff wall. Two siphon breakers in two 24-inch corrugated metal pipe (CMP) risers on the landside (LS) shoulder. Installed by USACE in 1952. Two slant pumps in a corrugated metal pump house mounted on a steel pile structure on the berm. 4-foot by 7-foot concrete inspection box for a Hersey-Sparling water meter on the berm in front of the pump house. Two flap gates in a 9.7-foot by 10.6-foot, outside dimensions, concrete distribution box at the LS toe. (16-inch steel irrigation discharge pipe through the levee, slant pumps, and all other appurtenances retained under Automatic Board Order (ABO) issued as Permit No. 10054, 1974 - William A. Lerner). [Additional Reference(s): DWR Levee Log, 1993. USACE Sacramento O&M Manual 128, March 1960, (HLM 30.29), 14-inch pipe referenced].

WS view: two slant pumps on wooden platform on levee berm.

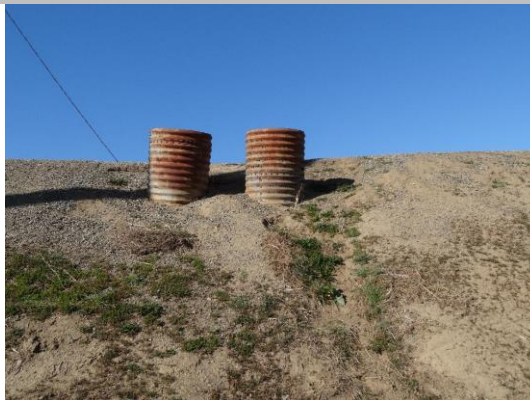
Photo 2 of 3 : UCIP\_FA\_2018\_50194\_51833.jpg

LS view: CMPs with leaky siphon breakers. Slope erosion and excessive vegetation on levee slope.

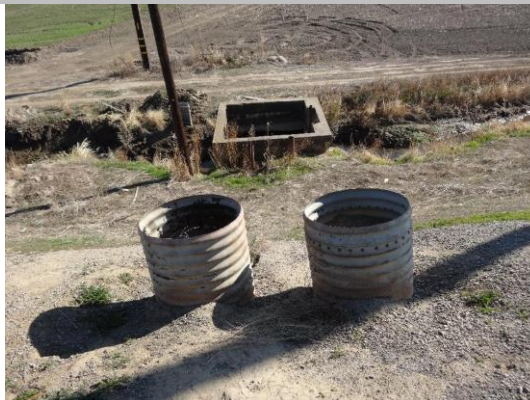
Photo 3 of 3 : UCIP\_FA\_2018\_50194\_52880.jpg

LS view: siphon breakers in CMP riser on levee slope and distribution box on levee toe.

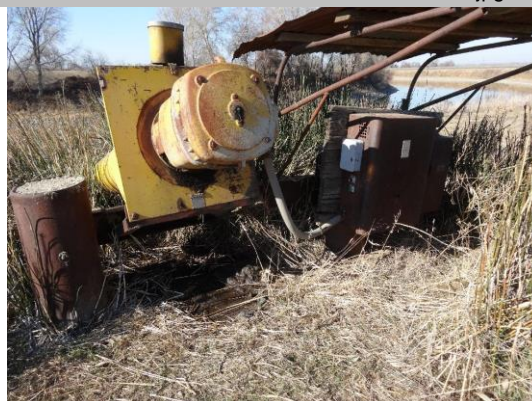
Photo 1 of 3 : UCIP\_FA\_2018\_50193\_51827.jpg

Comment Code						
Inspector Comment						
FS_ID:50193 DS_ID:20107 EP_NO: 6169 Repair Type: Non-Urgent Crossing Status: Found UCIP Comments: 08/29/2016: Pipe and pump are leaking oil. Could not find evidence of any water leak. Field hand may have spilled oil as there is a puddle of oil beneath the pump. Crossing downgraded from Urgent to Non-Urgent. (K. Fazel - UCIP)01/15/2014: Leaky pump and excessive vegetation observed along pipe alignment on waterside slope of the levee. It needs more investigations. May have new permit for slant pump. (P. Amatya - DWR) FIELD_STRUCT_DESC: 30-inch reinforced concrete encased steel irrigation discharge pipe through the levee, 15.5 feet below the crown. Two reinforced concrete cutoff walls. Slant pump and switch panel on steel pile structure at the edge of the berm. Slide gate in a 2.5-foot by 3.5-foot, inside dimensions, concrete riser on the berm. Pipe discharges into a 6-foot by 8-foot concrete distribution box at the landside (LS) toe. 2-inch conduit through the levee, 2.5 feet below the crown. (Replacement of an old pit pump with a new slant pump authorized under Permit No. 6169, 1968 - Leslie A. Butler). Pipe through the levee was initially installed in 1952. [Additional Reference(s): DWR Levee Log, 1993. USACE Sacramento O&M Manual 128, March 1960 (HLM 30.46)]. FS Date: 8/29/2016

WS view: leaky slant pump on levee berm.

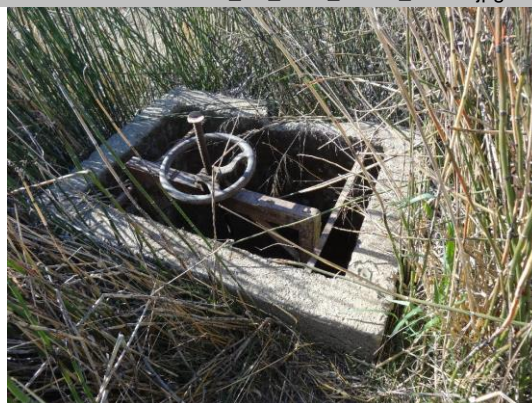
Photo 2 of 3 : UCIP\_FA\_2018\_50193\_51826.jpg

WS view: concrete surge box with slide gate on levee berm.

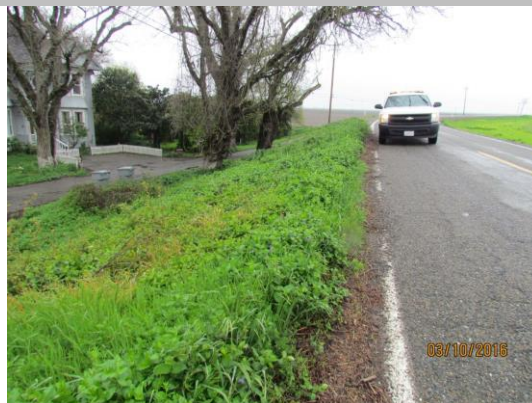
Photo 1 of 1 : FA\_2018\_RD1500\_189\_45\_20180904\_00023.jpg

LM Start	<b>30.22</b>	Rating **	M	Issue No.	<b>45</b>					
LM End	<b>30.22</b>	Issue Type +	En	Location *	LS					
Category	Earthen Levee		GPS Latitude/Longitude							
			Start	End						
Item	Vegetation		38.997027 °	38.997027 °						
			-121.794755 °	-121.794755 °						
DWR ID	DWR_RD1500_01_s_2012_45									
Comment Code										
V6 : Landscaping										
Inspector Comment

View of the groundcover on the landward side of the levee looking downstream. Spring 2016.

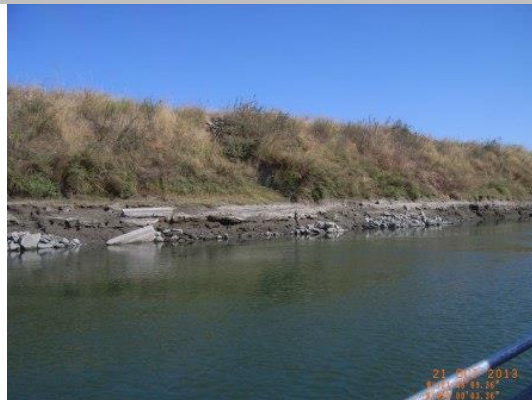
Photo 1 of 1 : FA\_2018\_RD1500\_189\_82\_20181023\_00047.jpg

LM Start	30.60	Rating **	A/W	Issue No.	82
LM End	30.75	Issue Type +	Ma	Location *	WS
Category	Supplemental			GPS Latitude/Longitude	
				Start	End
Item	2017 USACE Erosion Survey, DRAFT			38.999745 °	39.001413 °
				-121.800898 °	-121.802889 °
DWR ID	DWR_RD1500_01_f_2018_82				
Comment Code					
Inspector Comment					
2017 Site ID: SAC 116.0 L					
Status: Eroding					
2017 Field Notes: Minor new erosion throughout the site.					
Site History: 2000 - Eroding, vertical berm slope over a vertical cohesive toe; slow erosion but getting close to the toe. 2002 - Erosion is getting close to the levee, still eroding with some new small slumps.					
2004 - Some minor new erosion. 2006 - Some new erosion, cleaned off older scars and slump faces. 2008 - New, small, partial rotational failure. 2011 - Some new minor erosion. 2016 - Fresh erosion on lower bank.

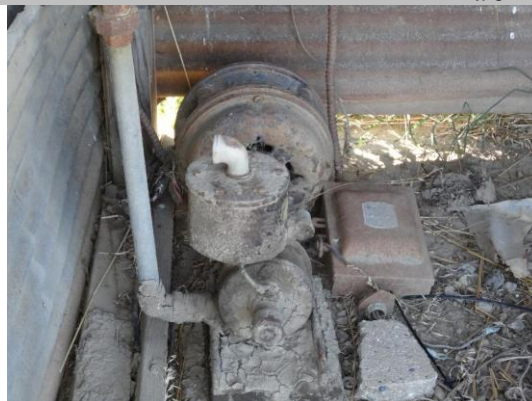
Photo 1 of 3 : UCIP\_FA\_2018\_28144\_51812.jpg

Comment Code					
Inspector Comment					
FS_ID:28144 DS_ID:20000 EP_NO: 15916 Repair Type: Non-Urgent Crossing Status: Found UCIP Comments: Surface erosion due to leaky pressure breaker on landside slope. FIELD_STRUCT_DESC: 18-inch steel irrigation discharge pipe through the levee, at an unknown depth. Waterside (WS) pump not mentioned in the Levee Log. Siphon breaker in a 24-inch corrugated metal pipe (CMP) riser on the landside (LS) slope. Pipe discharges into a 6-foot by 8-foot, inside dimensions, concrete distribution box at the LS toe. Installed by USACE in 1951. (12-inch steel irrigation discharge pipe through the levee and all other appurtenances retained under Automatic Board Order (ABO) issued as Permit No. 10034, 1974 - Leslie A. Butler. Replacement of the existing 12-inch discharge pipe with a new 18-inch discharge pipe through the levee authorized under Permit No. 15916, 1992 - Leslie A. Butler). [Additional Reference(s): DWR Levee Log, 1993. USACE Sacramento O&M Manual 128, March 1960, (HLM 31.26)]. FS Date: 1/15/2014

WS view: pump in CM pump house on levee shoulder. Looks abandoned.

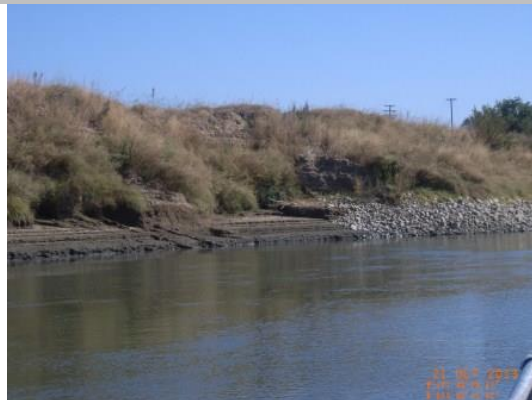
Photo 1 of 1 : FA\_2018\_RD1500\_189\_83\_20181023\_00048.jpg

Comment Code					
Inspector Comment					
2017 Site ID: SAC 116.5 L					
Status: Eroding					
2017 Field Notes: pipe and pump encroachment. site has been stable for a few years.					
Site History: 2003 - New sedimentation and some new small toe scallops at the upstream end; downstream end has some new erosion. 2004 - Some new erosion at the toe and upper bank and some small new rotational failures (mainly minor, except at the downstream end). 2007 - Some new slumps. 2009 - Some new scallops and site was extended upstream. 2010 - New deposition along upstream end of site, however there is also new erosion throughout the site. Site seems to be worsening, and eroding fast. Large habitat for bank swallows. 2011 - Some new minor erosion. 2012 - Minor new erosion. 2016 - Fresh erosion on lower bank.

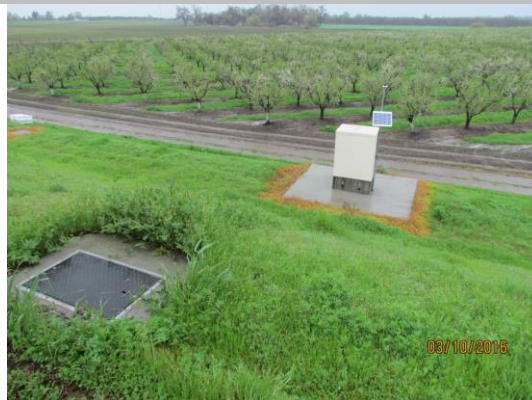
Photo 1 of 2 : FA\_2018\_RD1500\_189\_86\_20180904\_00034.jpg

LM Start	31.54	Rating **	A/W	Issue No.	86
LM End	31.54	Issue Type +	Ma	Location *	LS
Category	Earthen Levee			GPS Latitude/Longitude	
				Start	End
Item	Encroachments			39.006687 °	39.006687 °
				-121.814967 °	-121.814967 °
DWR ID	DWR_RD1500_01_s_2016_86				
Comment Code					
MW : Monitoring Well					
Inspector Comment					
UCIP installed this monitoring station for seepage in the area. Monitor for vandilism or damagePN: (18630).

View of the pizometer on the landward side of the levee. Spring 2016.

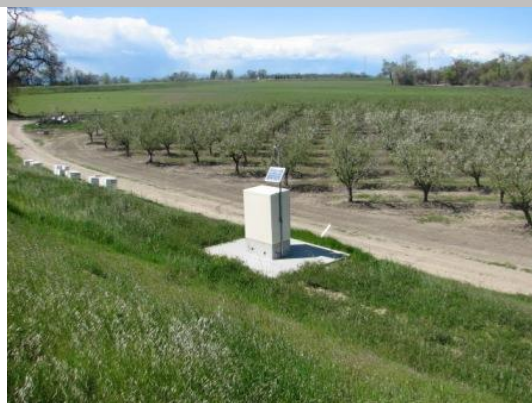
Photo 2 of 2 : FA\_2018\_RD1500\_189\_86\_20180904\_00035.jpg

The control unit for pizometers installed in 2012, photo taken spring 2012.

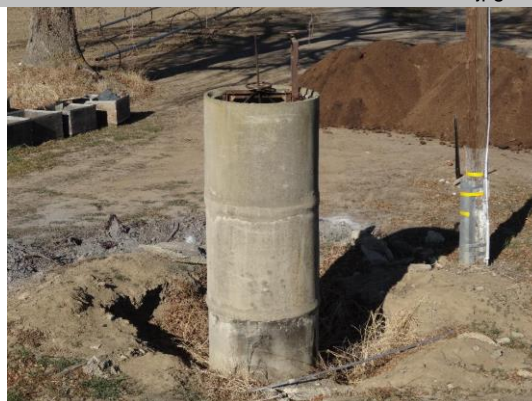
Photo 3 of 3 : UCIP\_FA\_2018\_28143\_51803.jpg

Item	DWR UCIP Field Study			39.006484 °	39.006484 °	
				-121.816168 °	-121.816168 °	
DWR ID	20077					
Comment Code						
Inspector Comment						
FS_ID:28143 DS_ID:20077 EP_NO: 9657 Repair Type: Non-Urgent Crossing Status: Found UCIP Comments: Looks abandoned. May need proper abandonment.Overhead power line. FIELD_STRUCT_DESC: *ABANDONED* 20-inch steel irrigation discharge pipe through the levee, 15 feet below the crown. Wooden step and walkway to vertical pump on pile structure in the river. Slide gate in a 2.5-foot by 3-foot, inside dimensions, riser. Concrete distribution box on the waterside (WS) slope. Switch panel on the berm. Pipe discharges into a 36-inch, inside diameter, concrete standpipe on the landside (LS). Installed by USACE in 1947. (Replacement of a section of 24-inch irrigation pipe through the levee authorized under Permit No. 9657, 1974 - Clyde M. Bell. 1.5-foot by 2-foot concrete culvert through the levee and all other appurtenances retained under Automatic Board Order (ABO) issued as Permit No. 10030, 1974 - Clyde M. Bell. Replacement of a cracked concrete pipe with a steel pipe at the LS toe authorized under Permit No. 13536, 1982 - Niechen N. V., Alfred Montna, Manager. Replacement of approximately 90 feet of 18-inch pipe in the overflow area of the Sacramento River with new steel pipe authorized under Permit No. 13941, 1984 - Niechen N. V., Alfred Montna, Manager). [Additional Reference(s): DWR Levee Log, 2005. USACE Sacramento O&M Manual 128, March 1960, (HLM 32.02), 2-foot by 2-foot concrete culvert referenced]. FS Date: 1/15/2014

LS view: concrete standpipe on levee toe.

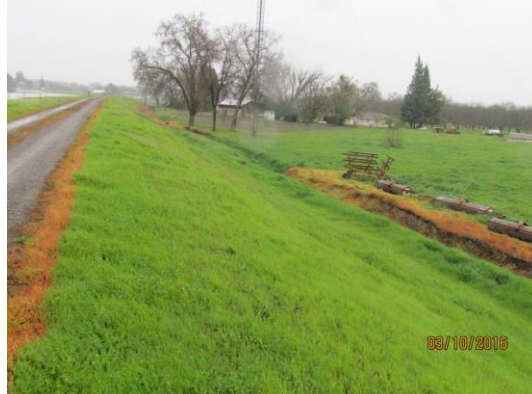
Photo 1 of 1 : FA\_2018\_RD1500\_189\_60\_20180904\_00027.jpg

LM Start	32.42	Rating **	M	Issue No.	60
LM End	32.57	Issue Type +	En	Location *	LS
Category	Earthen Levee			GPS Latitude/Longitude	
				Start	End
Item	Encroachments			39.013749 °	39.015620 °
				-121.825065 °	-121.823461 °
DWR ID	DWR_RD1500_01_s_2012_60				
Comment Code					
DT : Ditch					
Inspector Comment					
Ditch is located at the toe of the levee.

View of the ditch on the landward side of the levee looking upstream.  
Spring 2016.

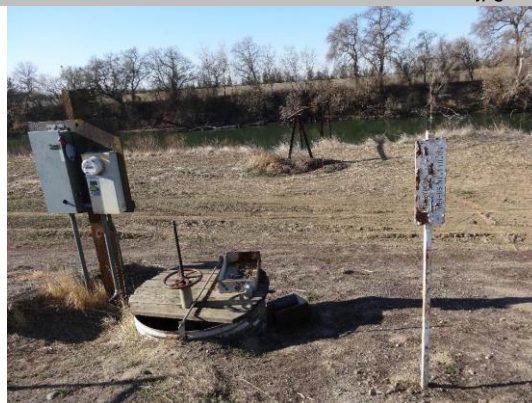
Photo 1 of 3 : UCIP\_FA\_2018\_28943\_53222.jpg

Comment Code						
Inspector Comment						
FS_ID:28943						
DS_ID:20018						
EP_NO: N/A						
Repair Type: Non-Urgent						
Crossing Status: Found						
UCIP Comments: Pipe leaks near pump through a hole in the pipe.						
Needs repair.An electric conduit through the levee. Concrete						
distribution box on landside levee toe. Slide gate in CMP on waterside						
slope.						
FIELD_STRUCT_DESC: 30-inch reinforced concrete encased steel						
irrigation discharge pipe through the levee, 16 feet below the crown. 2-						
inch steel conduit through the levee. Two reinforced concrete cutoff						
walls. Vertical pump on a structure in the river. Slide gate in a 48-inch						
corrugated metal pipe (CMP) riser on the waterside (WS) slope. Power						
pole and switch panel on the WS slope. Pipe discharges into a 5-foot by						
5-foot concrete distribution box in an irrigation ditch at the landside (LS)

WS view: power control panel and CMP riser with slide gate on levee slope.

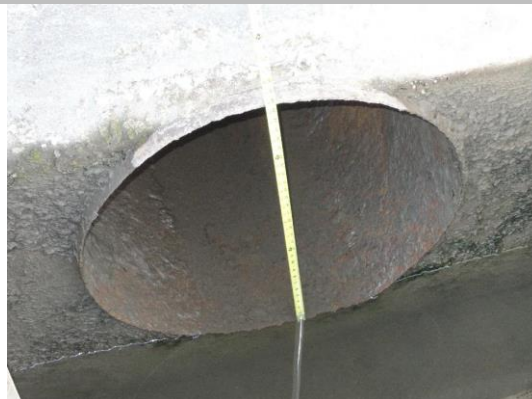
Photo 3 of 3 : UCIP\_FA\_2018\_28943\_53220.jpg

LS view: steel pipe in concrete distribution box on levee toe.

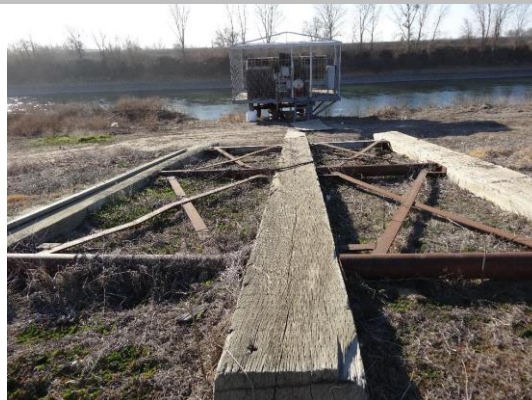
Photo 1 of 3 : UCIP\_FA\_2018\_28953\_53256.jpg

WS view: slant pumps on steel platform in shed on berm.

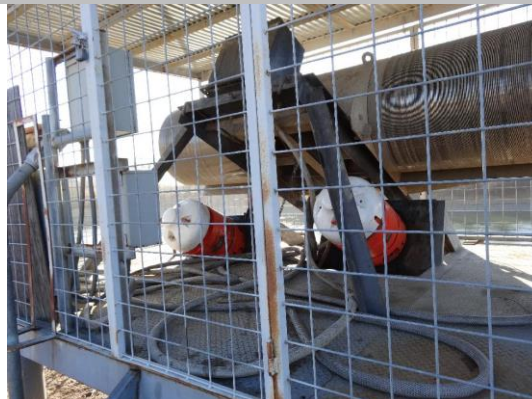
Photo 2 of 3 : UCIP\_FA\_2018\_28953\_53255.jpg

WS view: closer view of slant pumps on steel platform in shed on berm.

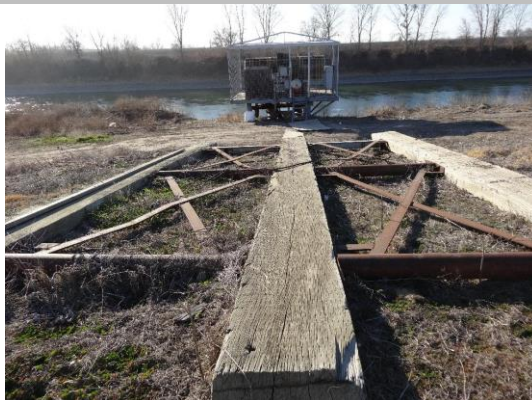
Photo 1 of 3 : UCIP\_FA\_2018\_28952\_53249.jpg

WS view: pump platform and shed on levee berm.

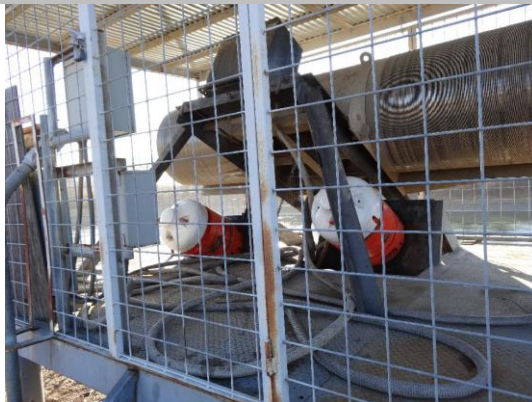
Photo 2 of 3 : UCIP\_FA\_2018\_28952\_53248.jpg

WS view: two slant pumps on steel platform at waterside berm.

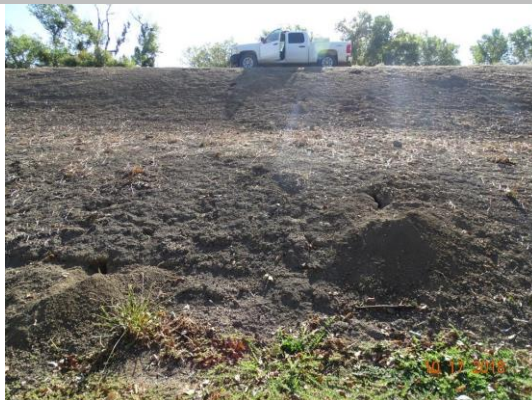
Photo 1 of 1 : FA\_2018\_RD1500\_190\_16\_20181018\_00041.jpg

LM Start	0.14	Rating **	M	Issue No.	16
LM End	0.14	Issue Type +	Ma	Location *	LS
Category	Earthen Levee			GPS Latitude/Longitude	
				Start	End
Item	Animal Control			38.762564 °	38.762564 °
				-121.672771 °	-121.672771 °
DWR ID	DWR_RD1500_02_f_2018_16				
Comment Code					
A3 : No rodents visible, but rodent burrows visible; need to backfill and compact or grout burrows.					
Inspector Comment					
Multiple holes on the landside slope.

View of rodent holes on the landside slope. Fall 2018.

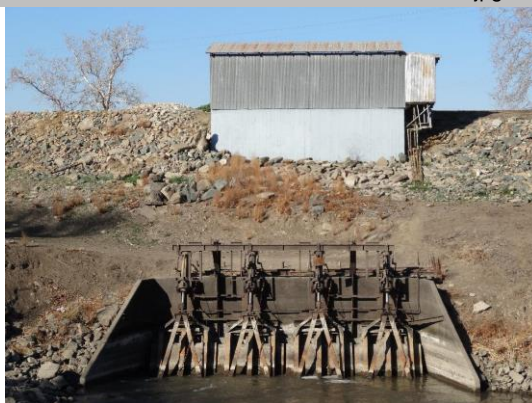
Photo 1 of 3 : UCIP\_FA\_2018\_28886\_53098.jpg

WS view: CM shed for slide gate on levee shoulder (top) and outfall structure at levee toe (bottom).

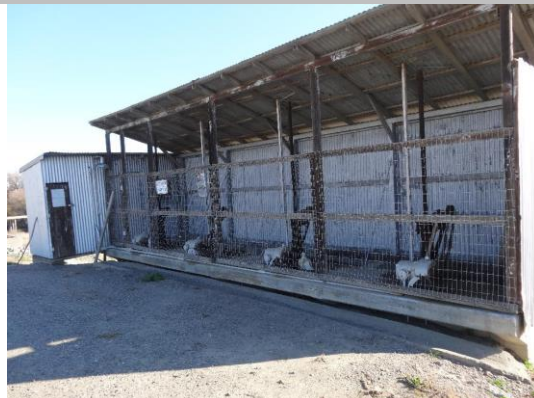
Photo 2 of 3 : UCIP\_FA\_2018\_28886\_53096.jpg

WS view: motorized slide gates in CM shed on levee shoulder.

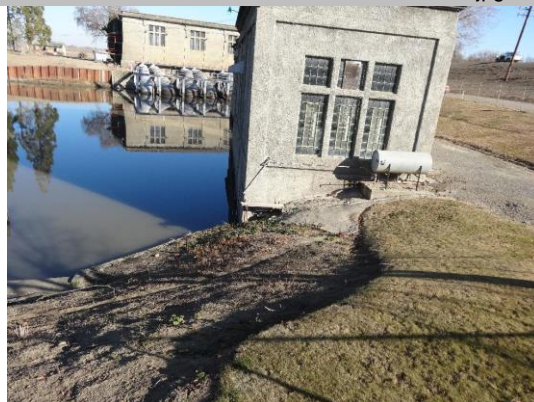
Photo 3 of 3 : UCIP\_FA\_2018\_28886\_53097.jpg

LS view: pump house at the end of levee berm.

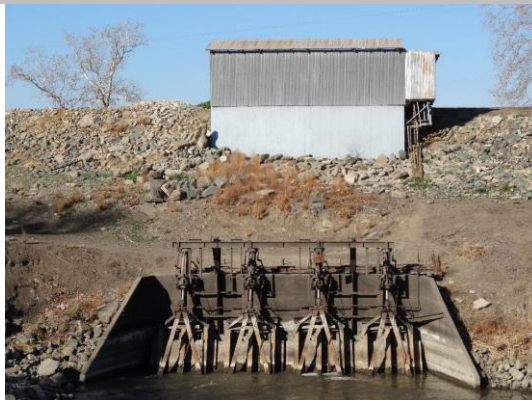
Photo 1 of 3 : UCIP\_FA\_2018\_28883\_53085.jpg

WS view: CM shed for slide gate on levee shoulder (top) and outfall structure at levee toe (bottom).

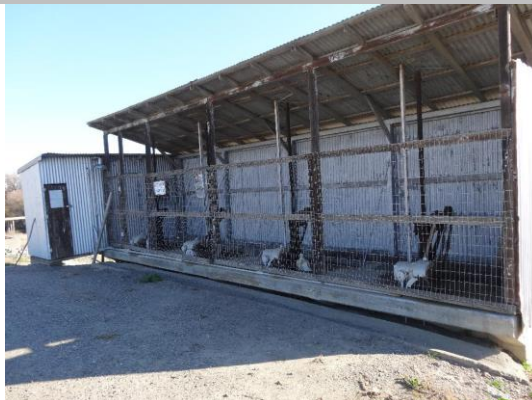
Photo 2 of 3 : UCIP\_FA\_2018\_28883\_53083.jpg

WS view: motorized slide gates in CM shed on levee shoulder.

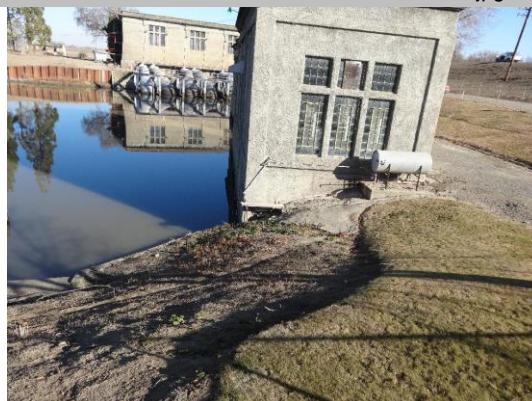
Photo 3 of 3 : UCIP\_FA\_2018\_28883\_53084.jpg

LS view: pump house at the end of levee berm.

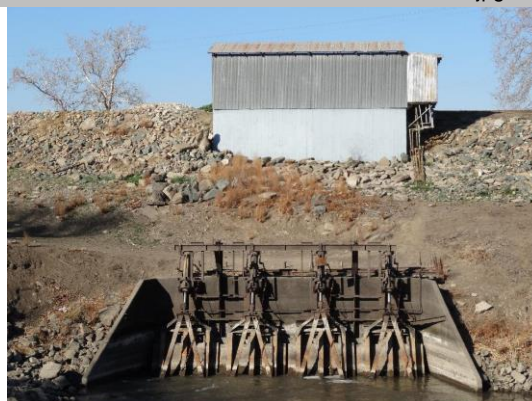
Photo 1 of 3 : UCIP\_FA\_2018\_28884\_53089.jpg

WS view: CM shed for slide gate on levee shoulder (top) and outfall structure at levee toe (bottom).

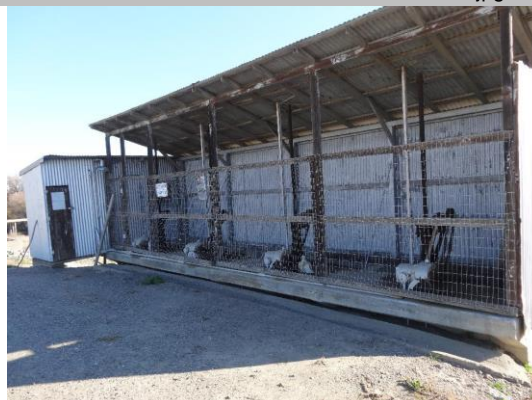
Photo 2 of 3 : UCIP\_FA\_2018\_28884\_53088.jpg

WS view: motorized slide gates in CM shed on levee shoulder.

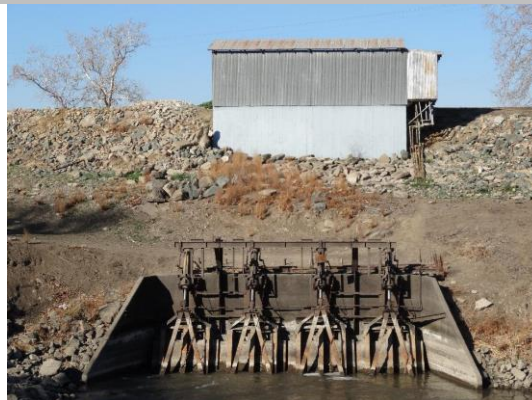
Photo 1 of 3 : UCIP\_FA\_2018\_28885\_53095.jpg

WS view: CM shed for slide gate on levee shoulder (top) and outfall structure at levee toe (bottom).

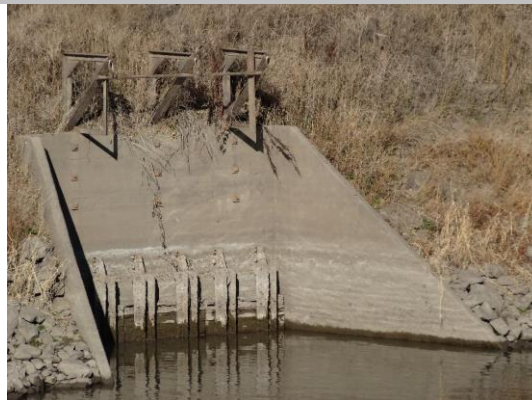
Photo 1 of 3 : UCIP\_FA\_2018\_28954\_53260.jpg

WS view: U type concrete headwall and flap gates on levee toe.

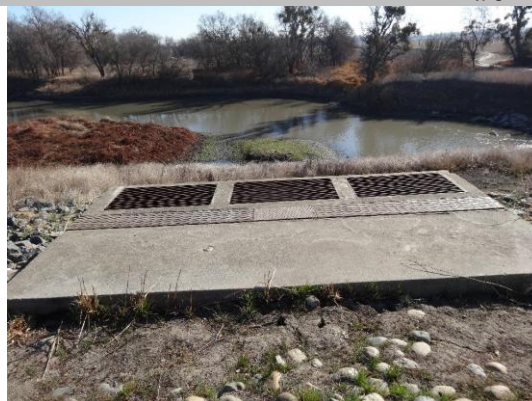
Photo 2 of 3 : UCIP\_FA\_2018\_28954\_53259.jpg

WS view: concrete surge structure on waterside shoulder.

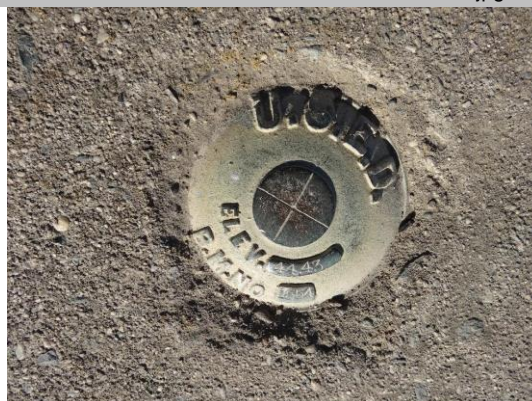
Photo 3 of 3 : UCIP\_FA\_2018\_28954\_53262.jpg

WS view: USED Bench Mark on concrete structure on levee shoulder.

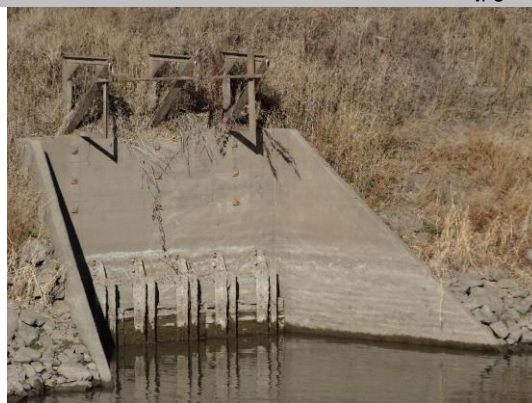
Photo 1 of 3 : UCIP\_FA\_2018\_28955\_53265.jpg

WS view: U type concrete headwall and flap gates on levee toe.

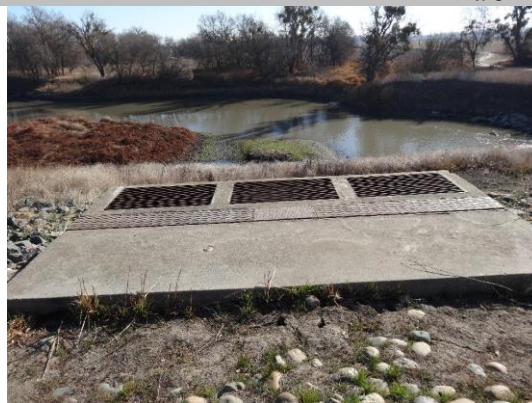
Photo 2 of 3 : UCIP\_FA\_2018\_28955\_53263.jpg

WS view: concrete surge structure on waterside shoulder.

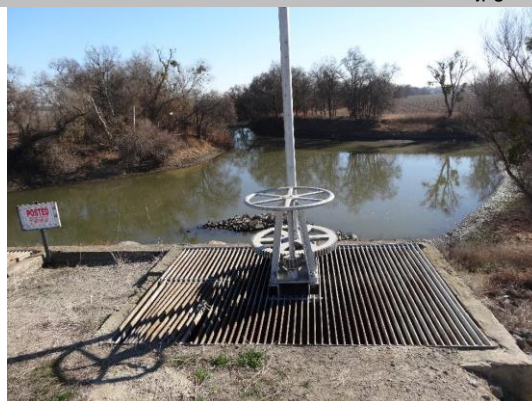
Photo 1 of 3 : UCIP\_FA\_2018\_28891\_53137.jpg

WS view: slide gate in concrete box on levee shoulder.

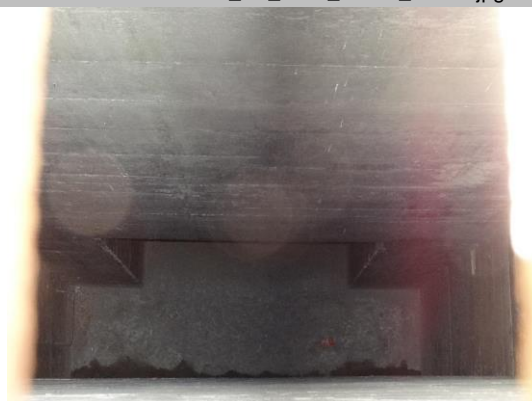
Photo 2 of 3 : UCIP\_FA\_2018\_28891\_53136.jpg

WS view: inside view of concrete box on levee shoulder.

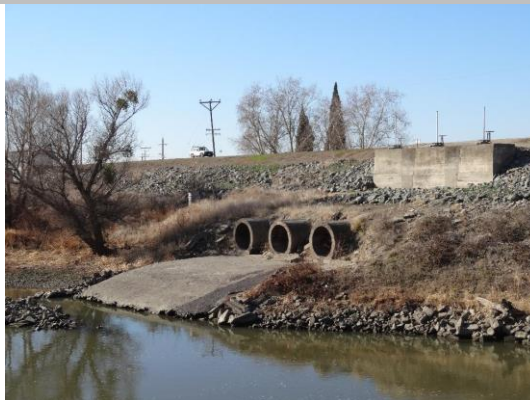
Photo 3 of 3 : UCIP\_FA\_2018\_28891\_53135.jpg

WS view: outfall structure on levee toe and concrete box on levee shoulder.

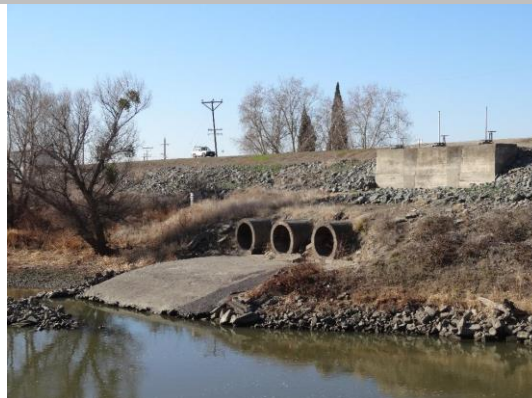
Photo 1 of 3 : UCIP\_FA\_2018\_28892\_53147.jpg

WS view: outfall structure on levee toe and concrete box on levee shoulder.

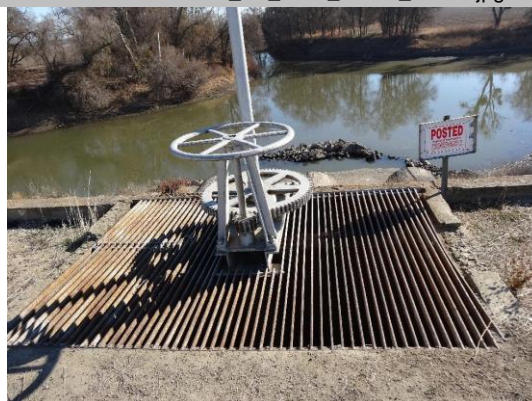
Photo 2 of 3 : UCIP\_FA\_2018\_28892\_53146.jpg

WS view: slide gate in concrete box on levee shoulder.

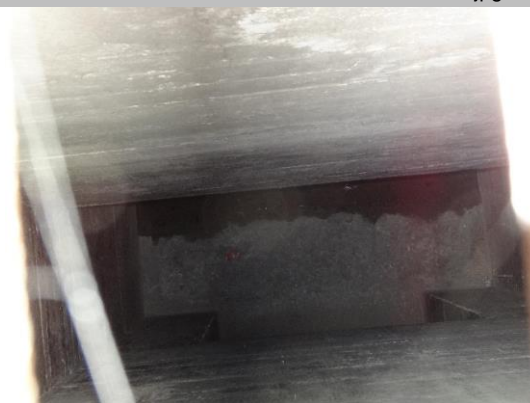
Photo 3 of 3 : UCIP\_FA\_2018\_28892\_53145.jpg

WS view: inside view of concrete box on levee shoulder.

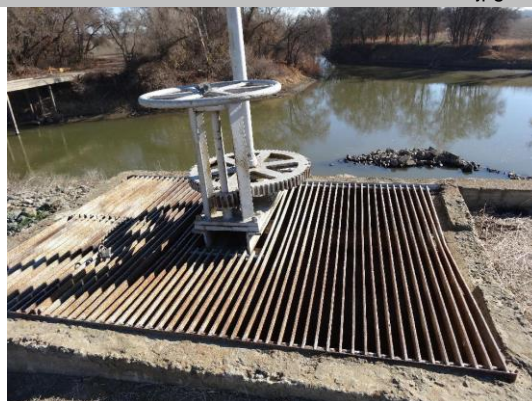
Photo 1 of 3 : UCIP\_FA\_2018\_28893\_53157.jpg

LM Start	<b>1.99</b>	Rating **	A/W	Issue No.	<b>52 (cont)</b>
LM End	<b>1.99</b>	Issue Type +	Ma	Location *

WS view: slide gate in concrete box on levee shoulder.

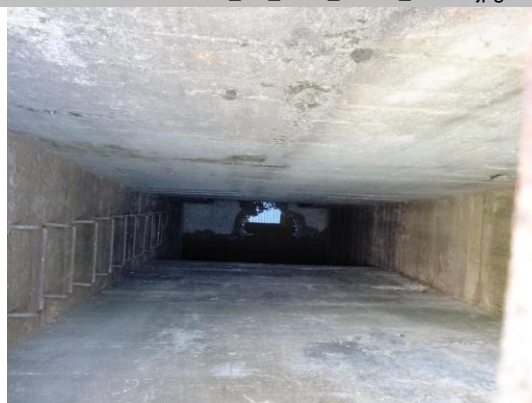
Photo 2 of 3 : UCIP\_FA\_2018\_28893\_53156.jpg

WS view: inside view of concrete box on levee shoulder.

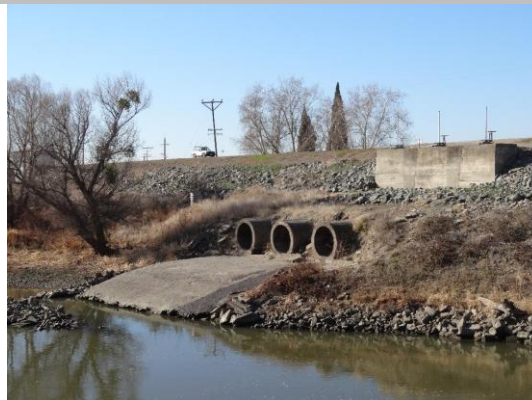
Photo 3 of 3 : UCIP\_FA\_2018\_28893\_53155.jpg

Comment Code					
Inspector Comment					
FS_ID:28893 DS_ID:20093 EP_NO: 10088 Repair Type: No Action Needed Crossing Status: Found UCIP Comments: Pumping plant was working during the field visit. Three 8.5 ft. X 8.5 ft. concrete box on waterside shoulder. FIELD_STRUCT_DESC: [Reclamation District No. 1500, Pumping Plant No. 1] 3 of 3: 84-inch by 84-inch reinforced concrete box drainage discharge conduit under the levee, 24 feet below the crown. Pumps in concrete pumping plant on the landside (LS). Slide gates mounted on a concrete structure on the waterside (WS) slope. Discharges in a concrete spillway and the borrow pit. Ramp on the WS slope. (84-inch by 84-inch reinforced concrete box drainage discharge conduit under the levee and all other appurtenances retained under Automatic Board Order (ABO) issued as Permit No. 10088, 1974 - Reclamation District No. 1500). [Additional Reference(s): DWR Levee Log, 2005. USACE Sacramento O&M Manual 129, June 1954, (Station 1224+75), three 78-inch concrete conduits referenced]. FS Date: 1/21/2014

WS view: outfall structure on levee toe and concrete box on levee shoulder.

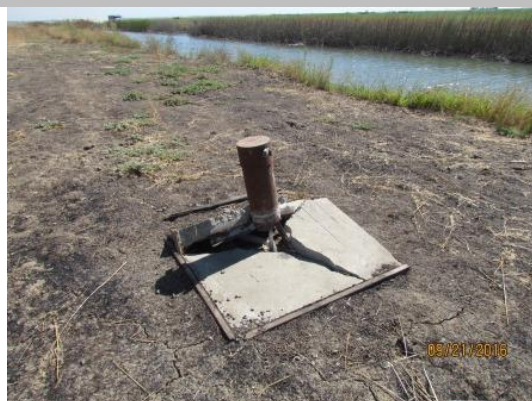
Photo 2 of 3 : FA\_2018\_RD1500\_190\_4\_20180904\_00002.jpg

Another view of damaged well. Fall 2016.

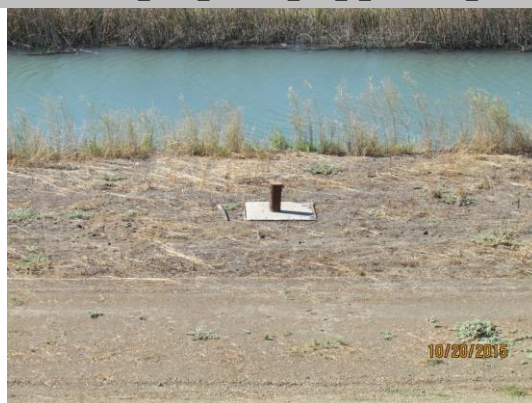
Photo 3 of 3 : FA 2018 RD1500 190 4 20180904 00003.jpg

View of the relief well at historical boil 12. Fall 2015.

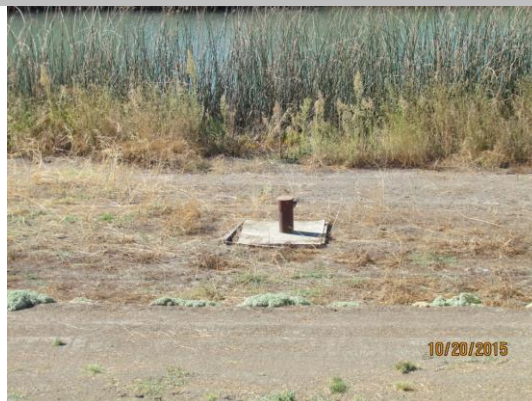
Photo 1 of 1 : FA\_2018\_RD1500\_190\_11\_20180904\_00004.jpg

A relief well at historical boil 16. Fall 2015.
